Case studies

Archetype case studies

The following archetype studies focus on how properties with different form factors can be successfully retrofitted in a variety of ways. They aim to provide real life examples for the illustrative archetypes shown in Chapter 4.

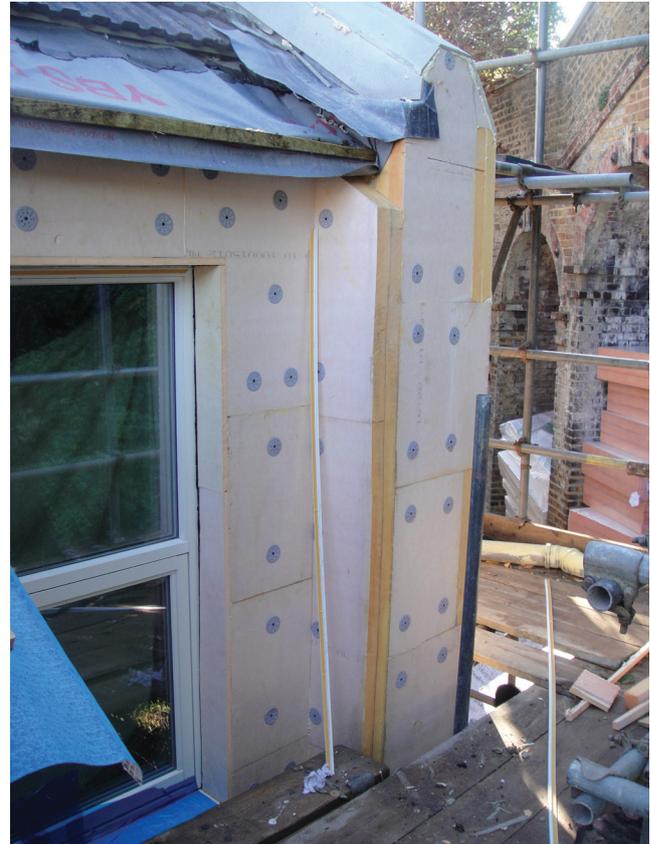
Figure 6.12 - Installation of external wall insulation - BBM Sustainable Design

- Ensure enough time in the project for negotiation with approving bodies and manage expectations.
- Material availability: 120mm Kooltherm was subject to minimum order, making two layers of 60mm necessary and resulting in increased labour, cost and duration of installation.
- Complexity of detailing to ensure continuity of air-tightness layer and insulation, and elimination of thermal bridges – the project team were keen to understand long-term how effective the installation has been.

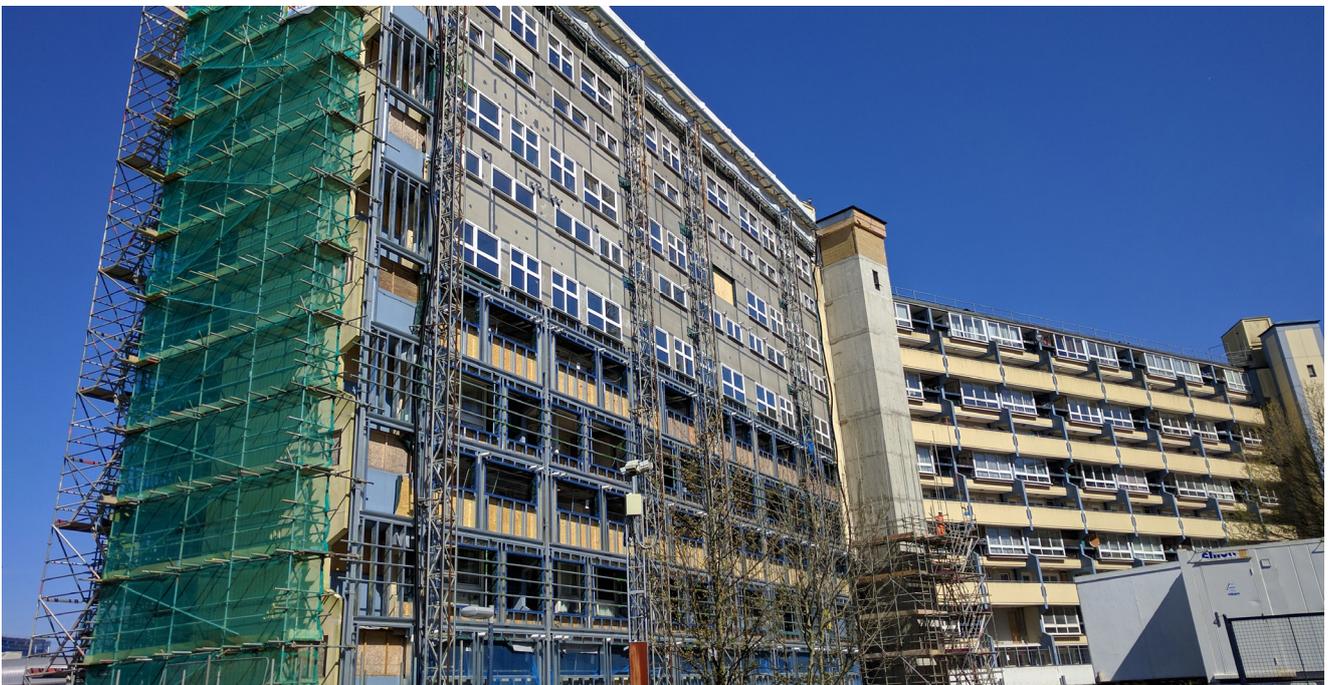
Figure 6.14 - Courtyard side during construction, showing new EWI and triple-glazed windows being fitted. ECD Architects.

corridors to be enclosed and allowed the living rooms to be extended to meet the new simplified external envelope. The existing stair cores were left uninsulated and outside the thermal envelope, which improved the building's form factor significantly. The 3 blocks were externally insulated with 300mm non-combustible mineral wool insulation, which wrapped the entirety of walls and roofs. The retrofit included the installation of triple-glazed windows and high-efficiency individual MVHR units in each flat.

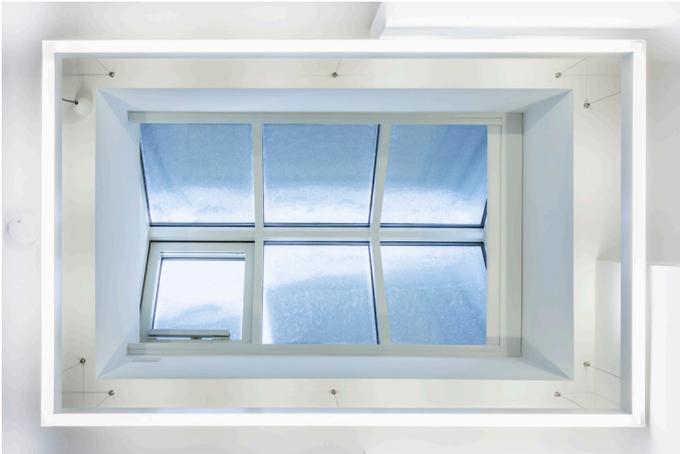
Figure 6.18 - Passivhaus certified rooflight, Feilden + Mawson LLP

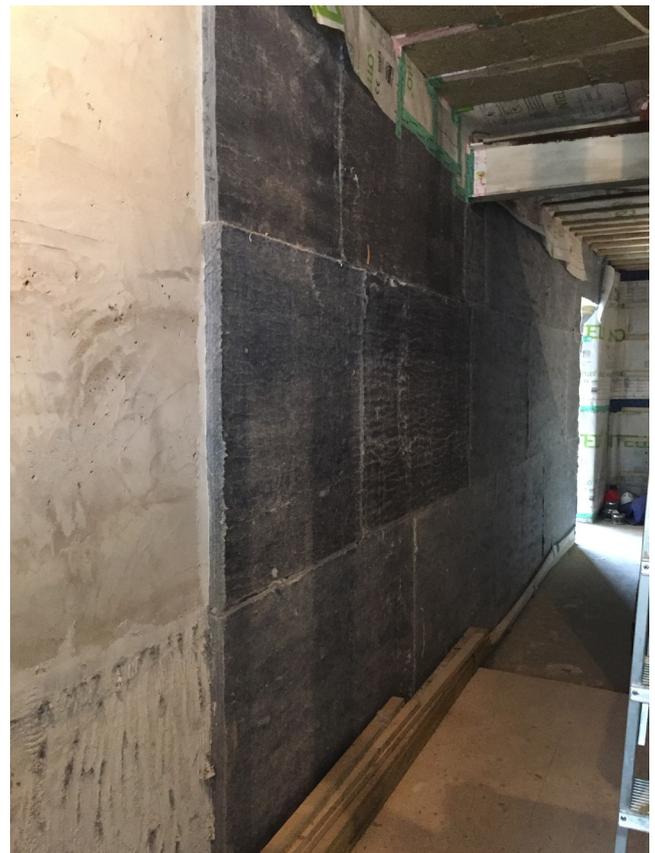
Figure 6.20 - Installation of internal wall insulation (40mm Aerogel applied to the internal walls to minimise loss of space), Feilden + Mawson LLP

The new internal layout retained the garage at ground level, which led to a larger than average form factor; the heat loss area is 396m² and TFA (treated floor area) is 121m². The fabric upgrade was robust; the internal walls were insulated with 40mm Aerogel to avoid a reduction in internal floor area, an airtightness membrane with 30mm service void and magnesium oxide board finished with lime plaster and breathable paint. The airtight layer in the build-up of the building envelope had to be carefully detailed around the interfaces between new and existing elements. This included connections between existing external walls and new structure. Likewise the insulation was carefully detailed to eliminate thermal bridges, in particular, around the internal garage volume. Existing windows were refurbished and new triple-glazed secondary glazing fitted along with Passivhaus certified front door and rooflights.

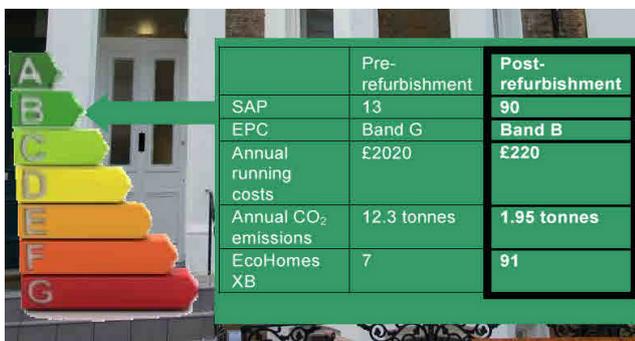
Figure 6.23 - SAP rating post retrofit

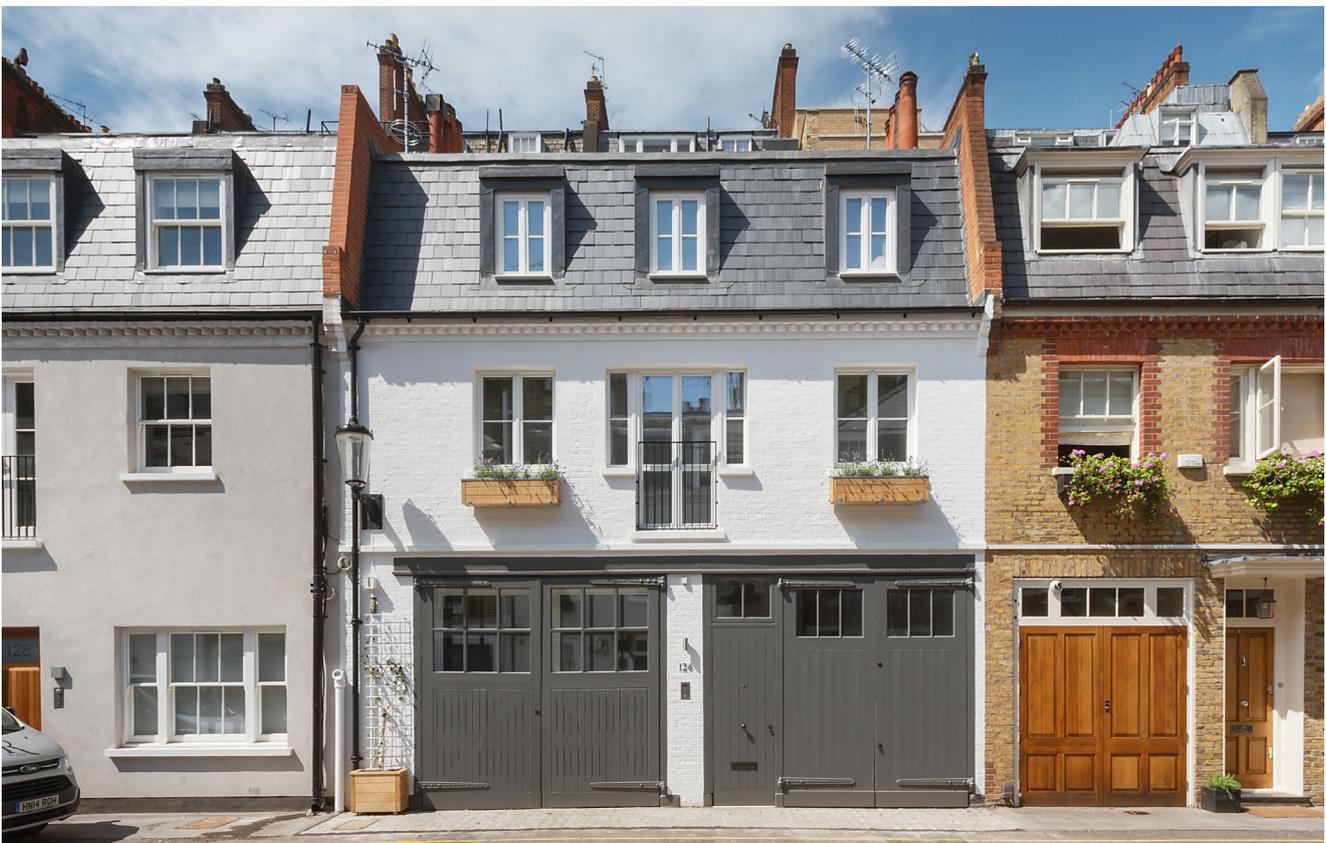
Figure 6.24 - Front post retrofit.

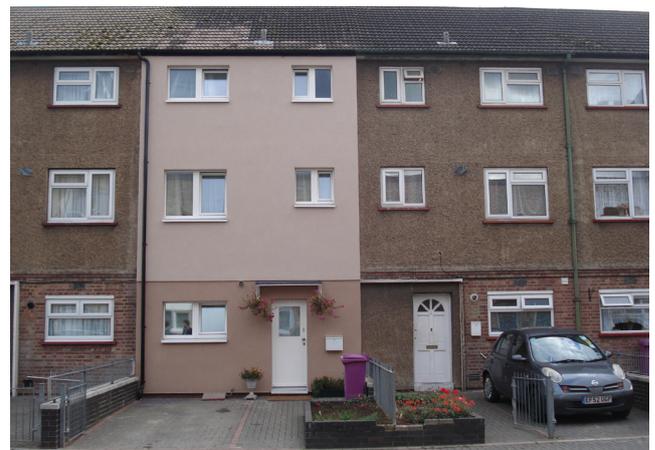
Figure 6.27 - Front post retrofit, bere:architects

→ 200mm and 250mm EPS external insulated render system to front and rear walls.

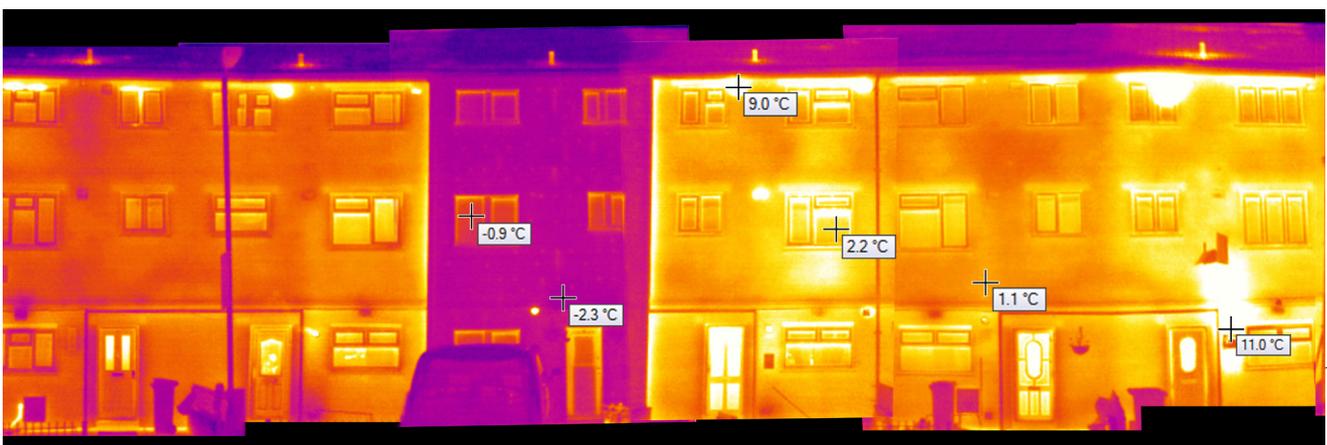
Figure 6.28 - Thermal imaging winter 2012 post retrofit, bere:architects

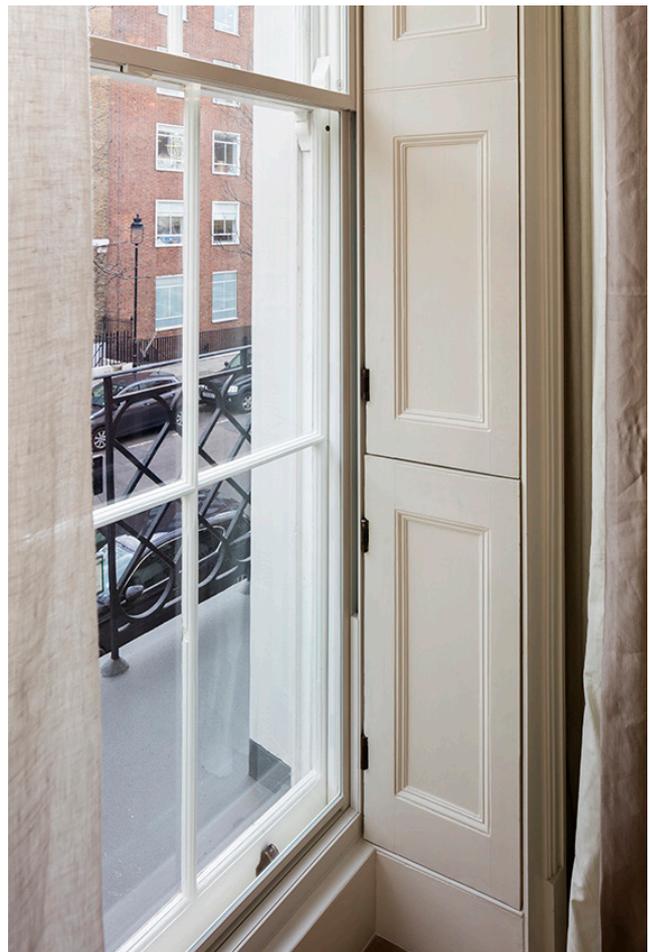
Figure 6.29 - High performance secondary glazing post retrofit. Prewett Bizley Architects

Perhaps the greatest challenge was how to tackle the very large multi-pane sash windows. While most of these were not original (in fact they were mostly

later Victorian replacements) the conservation officer would not accept replacement sashes with insulating glass.

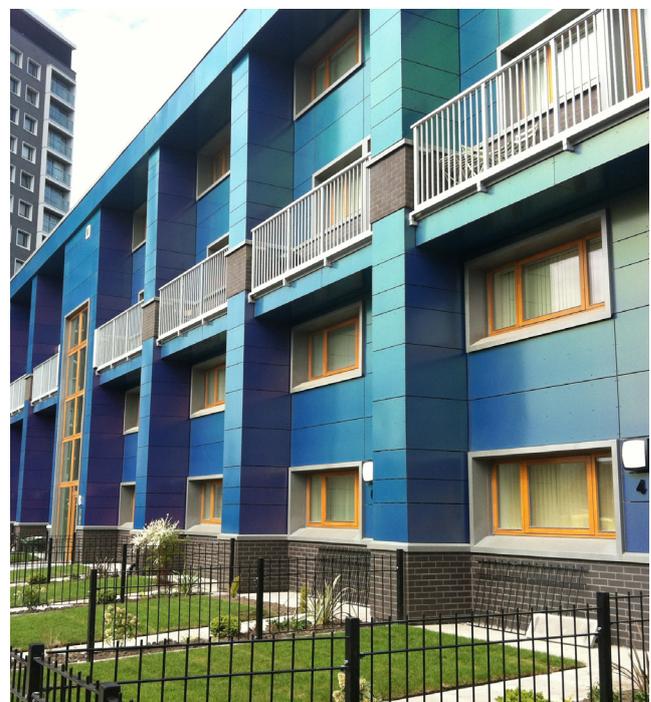
Figure 6.31 - Close up after retrofit

The solution adopted was to wrap the balconies and features with insulation and use insulated skirting where cold spots were found. Several different variations were implemented as the building works progressed and a great deal of thermal analysis was undertaken to support the best solution.

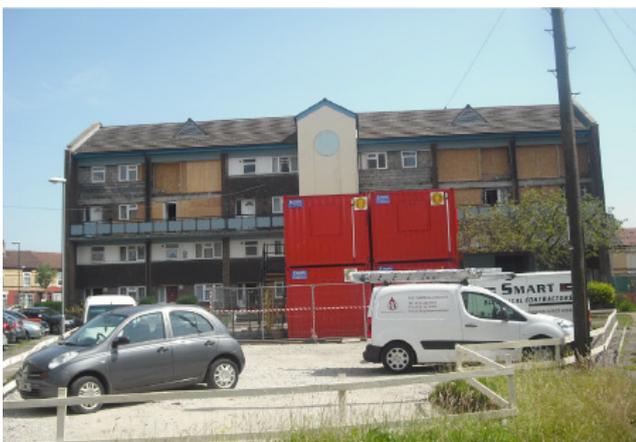
Figure 6.32- Elevation prior to retrofit

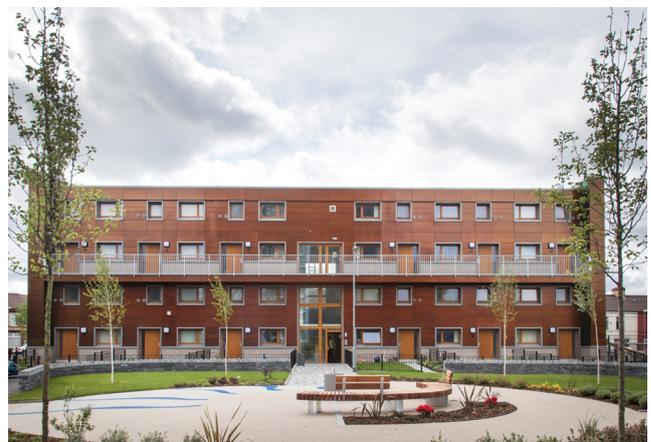
Figure 6.33 - Elevation post retrofit

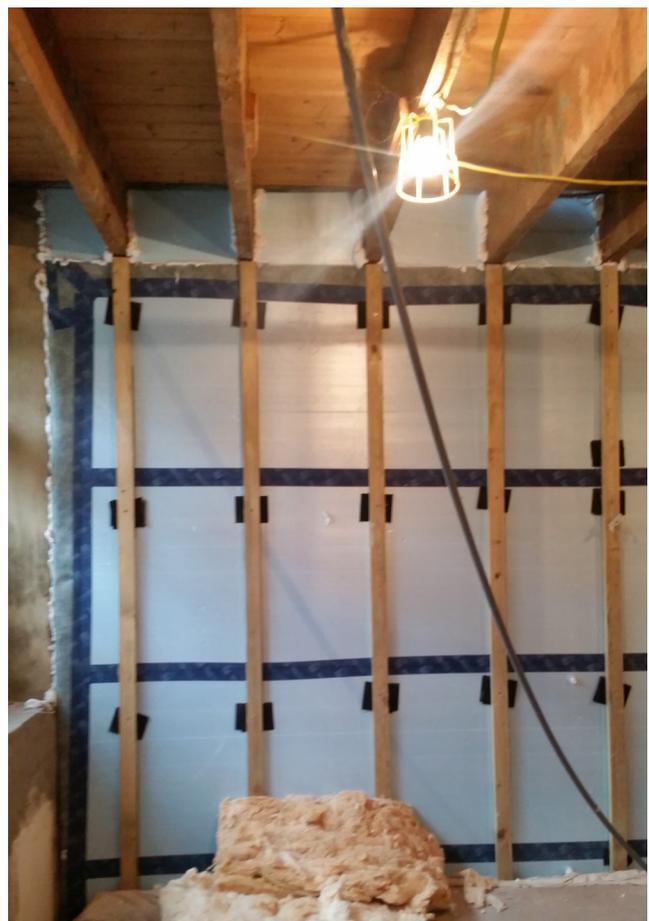
Figure 6.35 - Internal wall insulation to original external building envelope which was mostly cavity but solid in isolated location, Marion Baeli and Robert Prewett

Step 2 took place over 2 weeks, 3 years after the original works. It involved the complete renewal of the front and rear façades which were infill construction between the party walls. The cavity wall infill was removed and replaced with super insulated timber framing. New triple glazed windows were fitted with attention paid to avoiding the cold bridges particularly with the party wall brickwork. A precast concrete beam at first floor which was part of the original construction, required careful insulation with thin vacuum insulation panels. Following the installation of the new windows the envelope was tested for air tightness, achieving a 0.7 ach @ 50 Pa result. It is hoped that the final compliance test will remain below 1.0 in order to achieve EnerPHit.

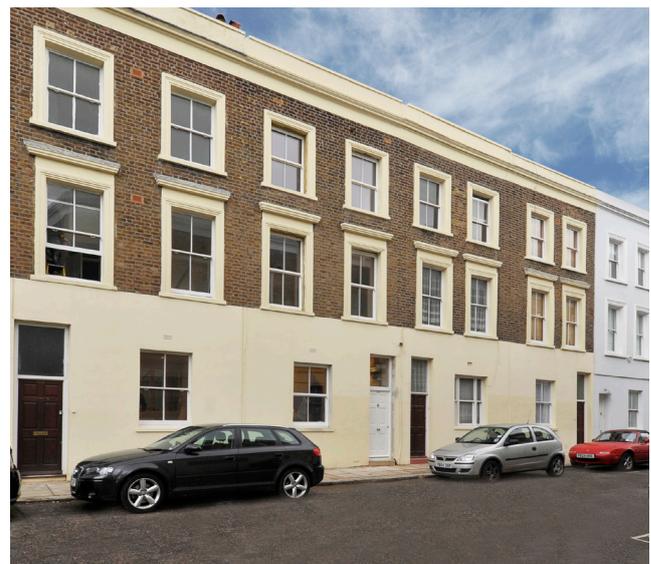
Figure 6.36 - Front post retrofit, Paul Davis + Partners

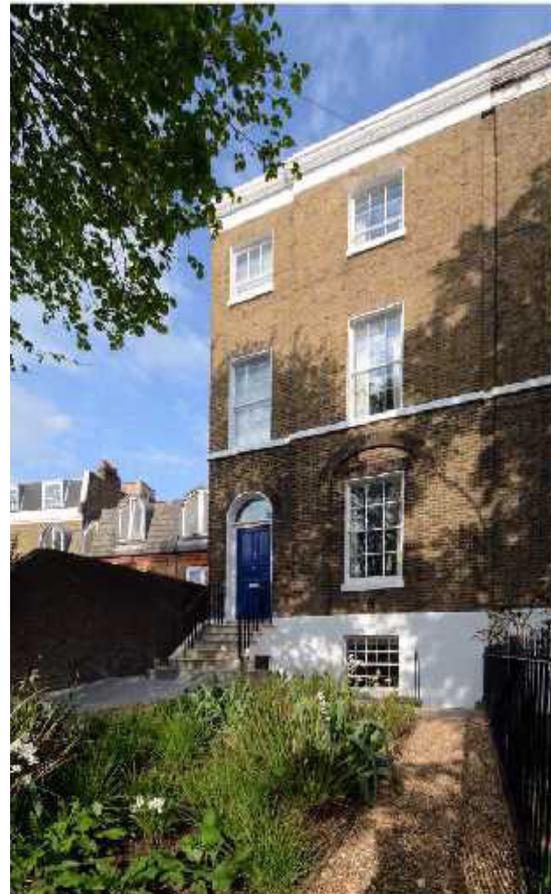
Figure 6.38 - Front elevation, Arboreal Architecture
